Australian Government
Department of Defence
Defence Science and
Technology Organisation

F-111 Adhesive Bonded Repairs Assessment Program - Progress Report 2: Analysis of FM300-2K Repairs

DSTO-TR-3088

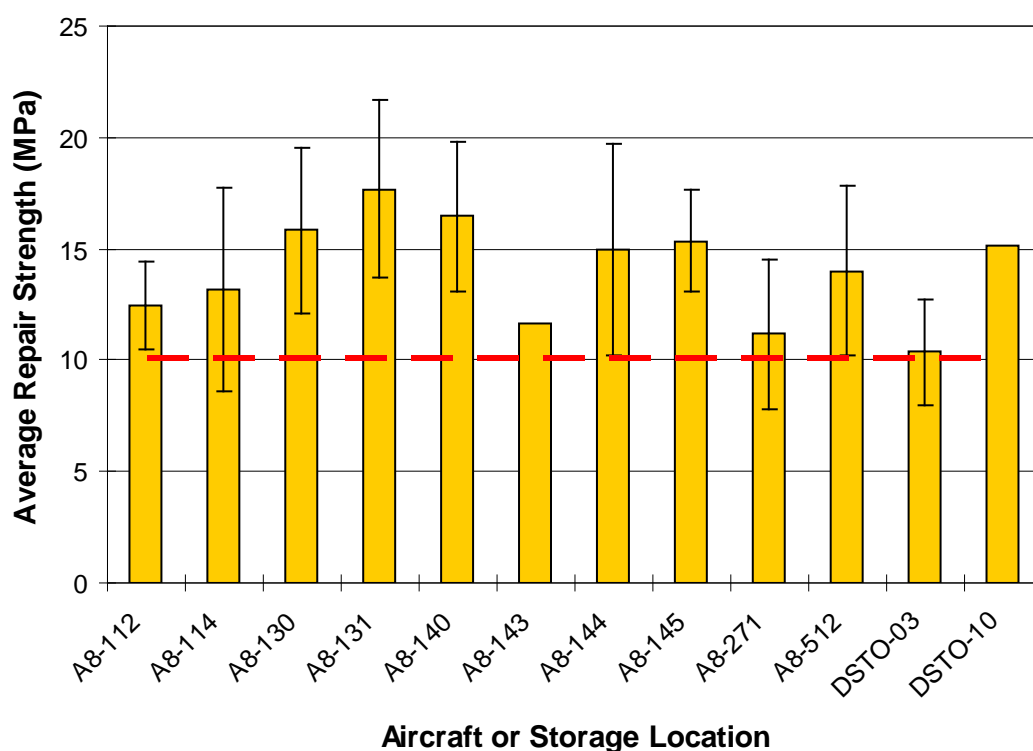
Figure 8 Average repair strength for each aircraft examined or for components recovered from storage locations. The dataset has stub results reported in Table 2 removed. The broken red line represents the lower limit expected for undegraded bonds accounting for possible geometrical variations in loading.

Specifically, repairs number three, four and five from A8-114 had ten pull stub tests carried out between them and eight of the ten tests had strengths below 10 MPa. On Aircraft A8-271, all three stubs on repair 5 had strengths lower than 10 MPa. On repair 13, all three stubs had strengths below 10 MPa, as well as all three stubs on repair 14, and two of the three stubs on repair 18. Where the repair strength average of all stubs dropped below 10 MPa, the individual stubs were examined in further detail, shown in Table 3. It

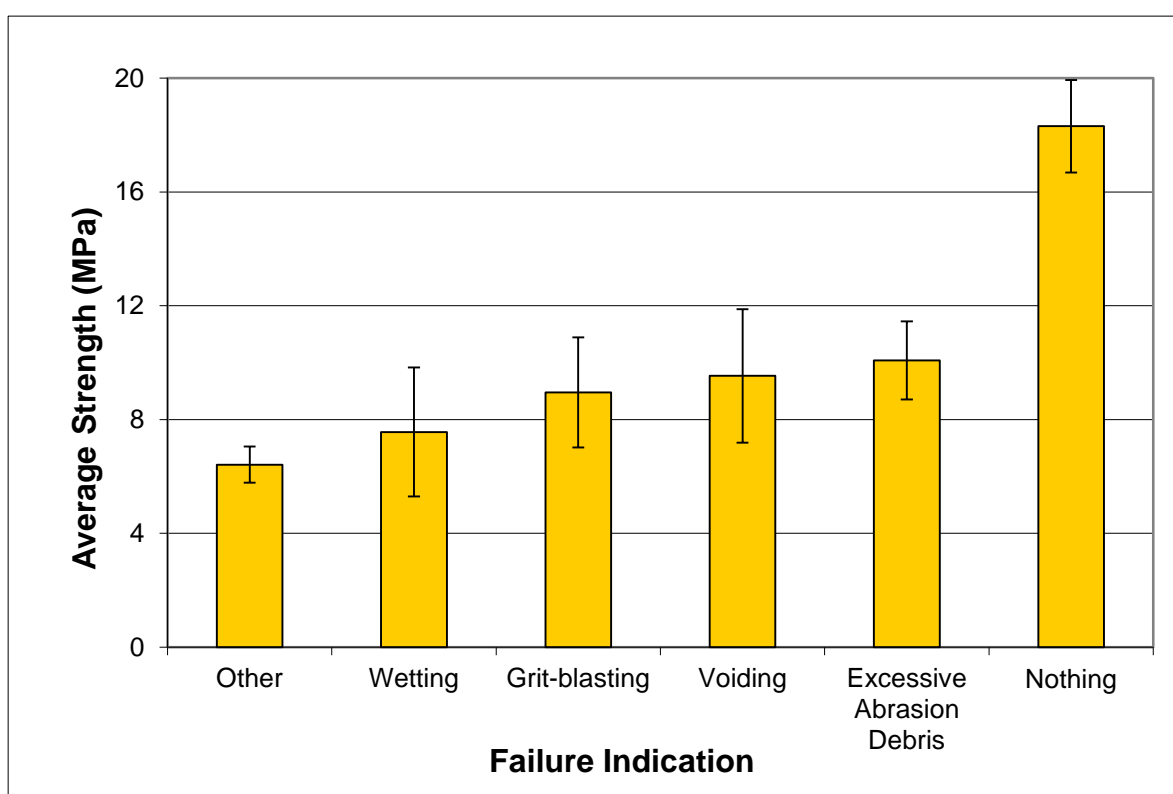
A summary of the failure indications and the average strength associated with each type is provided in Figure 12 below. Many stubs had two or three possible failure indications, in which case the stub was counted against each category. The results indicate the average strength for each indication type, with the spread in data shown by error bars, which represent the 95% confidence limits. The plot provides a useful measure of the relative severity of each type of failure with respect to the reduction in the overall stub strength in the locally affected areas. Stubs that fell into the “other” category had the lowest strength. One stub was close to a fastener hole, and this stub is examined in detail in Section 5.2. One stub had an operator comment that the stub may have failed in the peel mode rather than pull-off tension due to test configuration, and three more were on highly curved surfaces which have a higher likelihood of being affected by peel due to piston misalignment. It is understood that a peel failure component leads to a lower measured pull-off tension strength. However, it is difficult to exclude repairs on curved surfaces as the majority of aircraft surfaces are curved. Several stubs from repair 271-12 were placed in the “other” category, as this repair showed a severe deficiency in bond preparation, which will be examined in further detail in Section 5.1.

Excessive voiding was originally noted as a possible cause of failure, however, as shown in Figure 12, the average strength of stubs that presented voiding was 9.5 MPa, which is only slightly lower than the nominal “pass” value of 10 MPa. The presence of excessive abrasion debris, thought to indicate poor cleaning, was originally noted as a possible cause of low failure strength, however with an average strength of 10.1 MPa and with excessive abrasion debris present on many high strength stubs, the effect on the bond strength may be minimal, as discussed in further detail in Section 5.1.

Figure 12 Average strength for individual pull-stubs with failure indications categorised according to problems with adhesive wetting (wetting), inadequate grit-blasting (grit-blasting), high levels of voiding (voiding) adhesion failure with no identified cause (adhesion failure), and uncategorised causes (other). The strengths are compared to stubs measured on the same repairs without any indications (nothing).
